NISTIR 4724

Preliminary Study of the 1991 Oakland Hills Fire and Its Relevance to Wood-Frame, Multi-Family Building Construction

November 1991

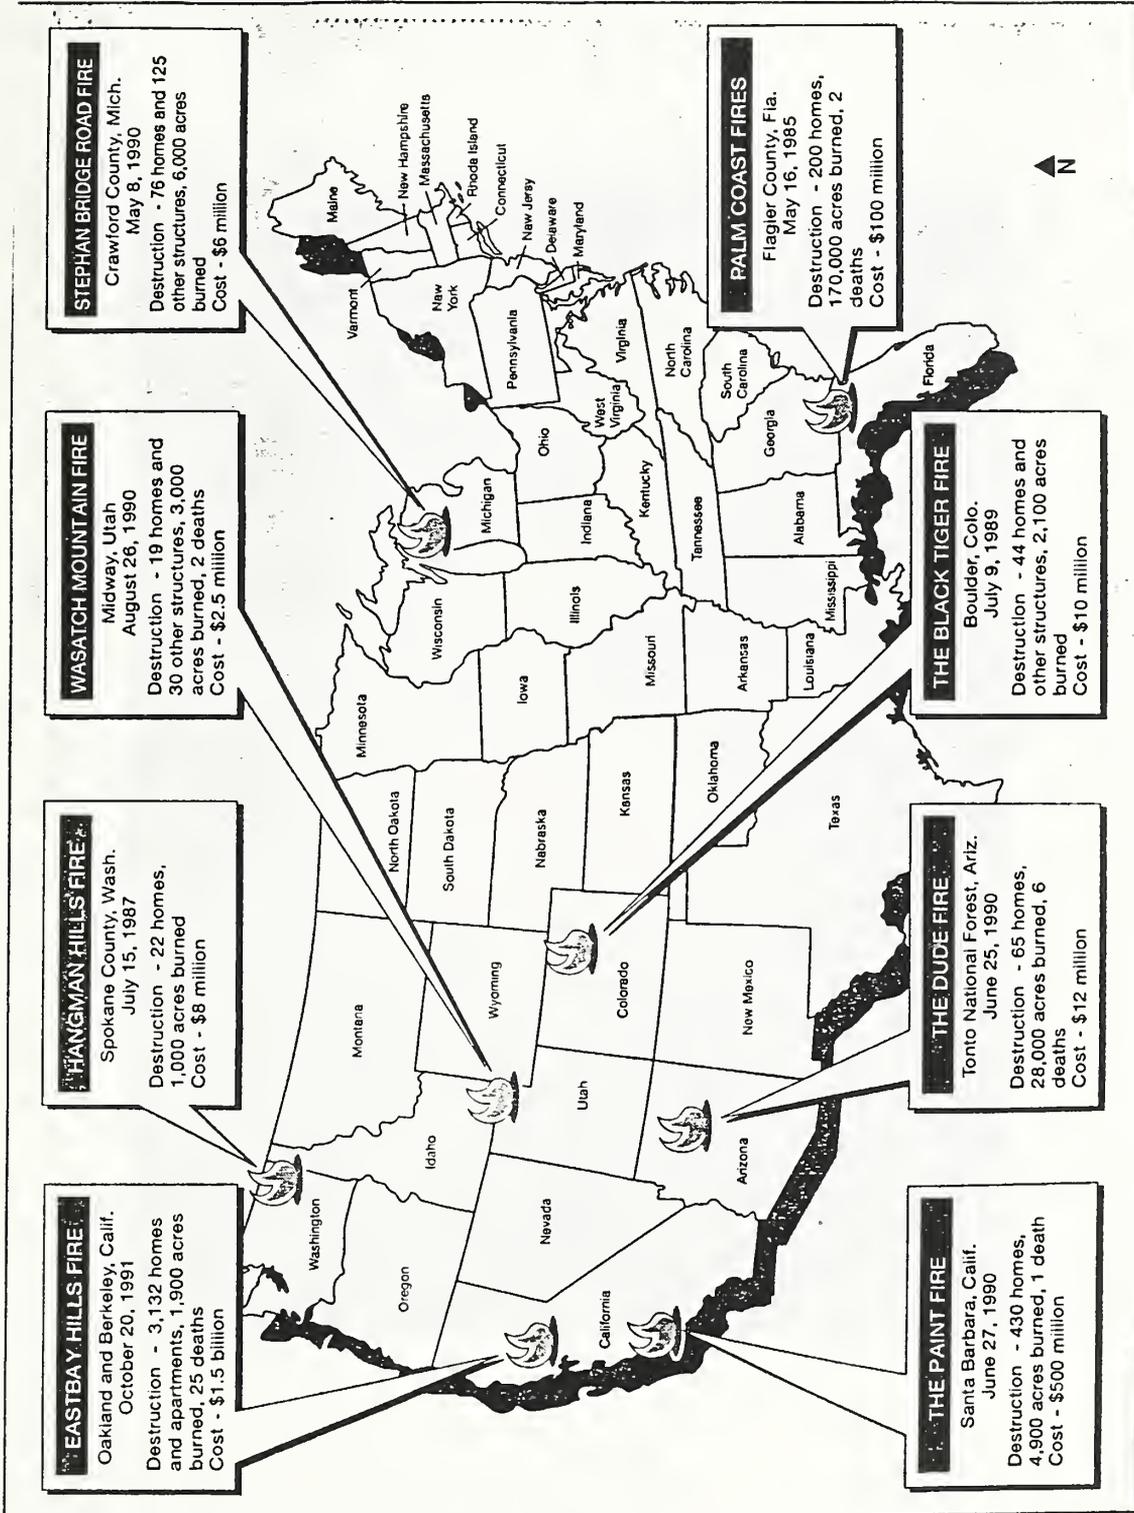
similar to the Oakland hills fire could occur again. In fact, in the United States an average of four hundred homes per year from 1986 to 1989 were destroyed in wildland/urban fire, see figure 7.

Figure 7. Recent wildland/urban fires in the United States. (Chart by Paul Grabowicz and Dan Hubig, published in the Oakland Tribune, October 31, 1991).

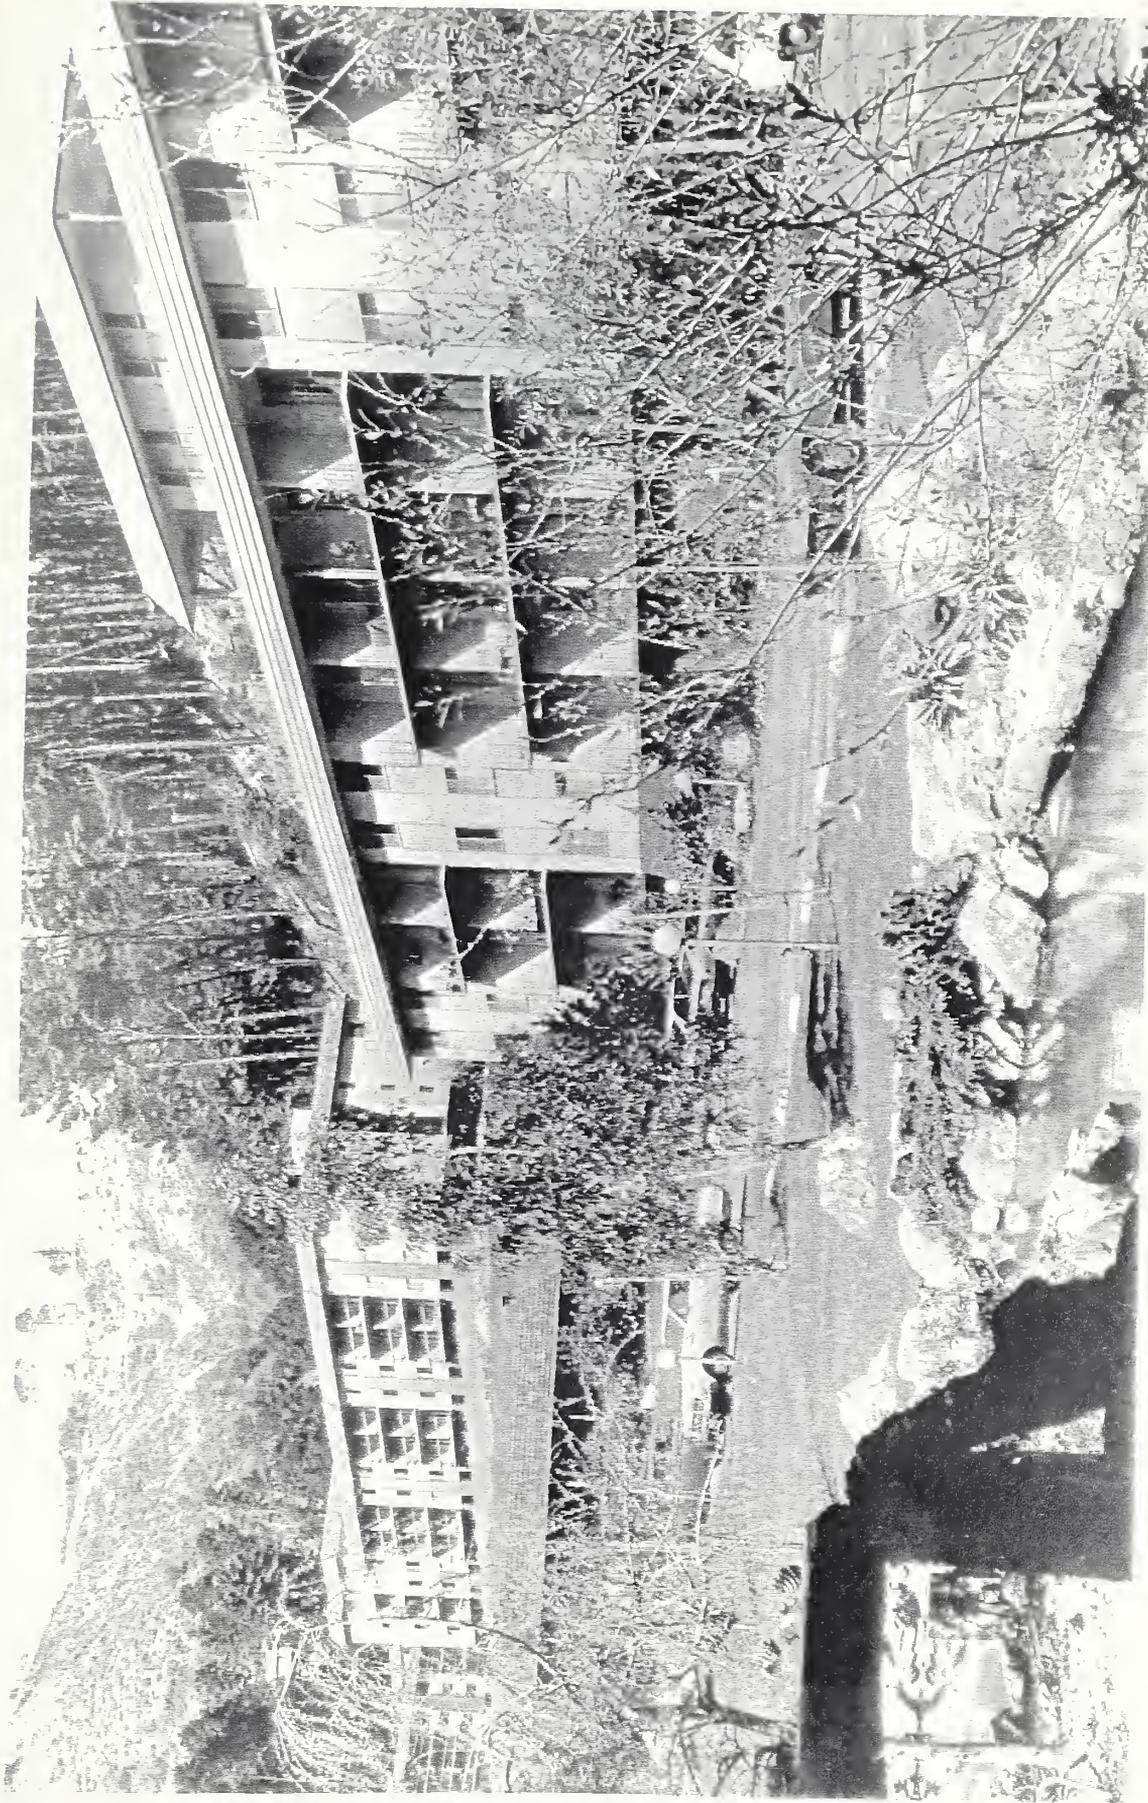
The apartment buildings were constructed before 1980. Figure 10 shows two of the three-story apartment buildings before the fire. Based on ICBO codes, published in the early 1970's, the three-story wood-frame apartment building structures would have been required to have one-hour rated construction throughout. As these codes permitted ordinary roofing, it is possible that the built-up roof covering was nonrated. The flat roof apartment buildings, which were built in a valley surrounded on three sides with steep hills in which the fire started, were probably subjected to repeated landing of fire brands which caused multiple ignitions of the roof. The presence of numerous eucalyptus tree fragments observed throughout the fire zone and reports of others having landed as far away as the other side of San Francisco bay, indicate that the eucalyptus trees were a probable source of flaming brands that influenced the spread of the fire. Figure 11 shows burning on the roof and third story apartment in one of the Parkwoods Apartment buildings during the Oakland hills fire.

Figure 10. Buildings in the Parkwoods Apartments complex prior to the fire.
(Photograph from Oakland Tribune files)

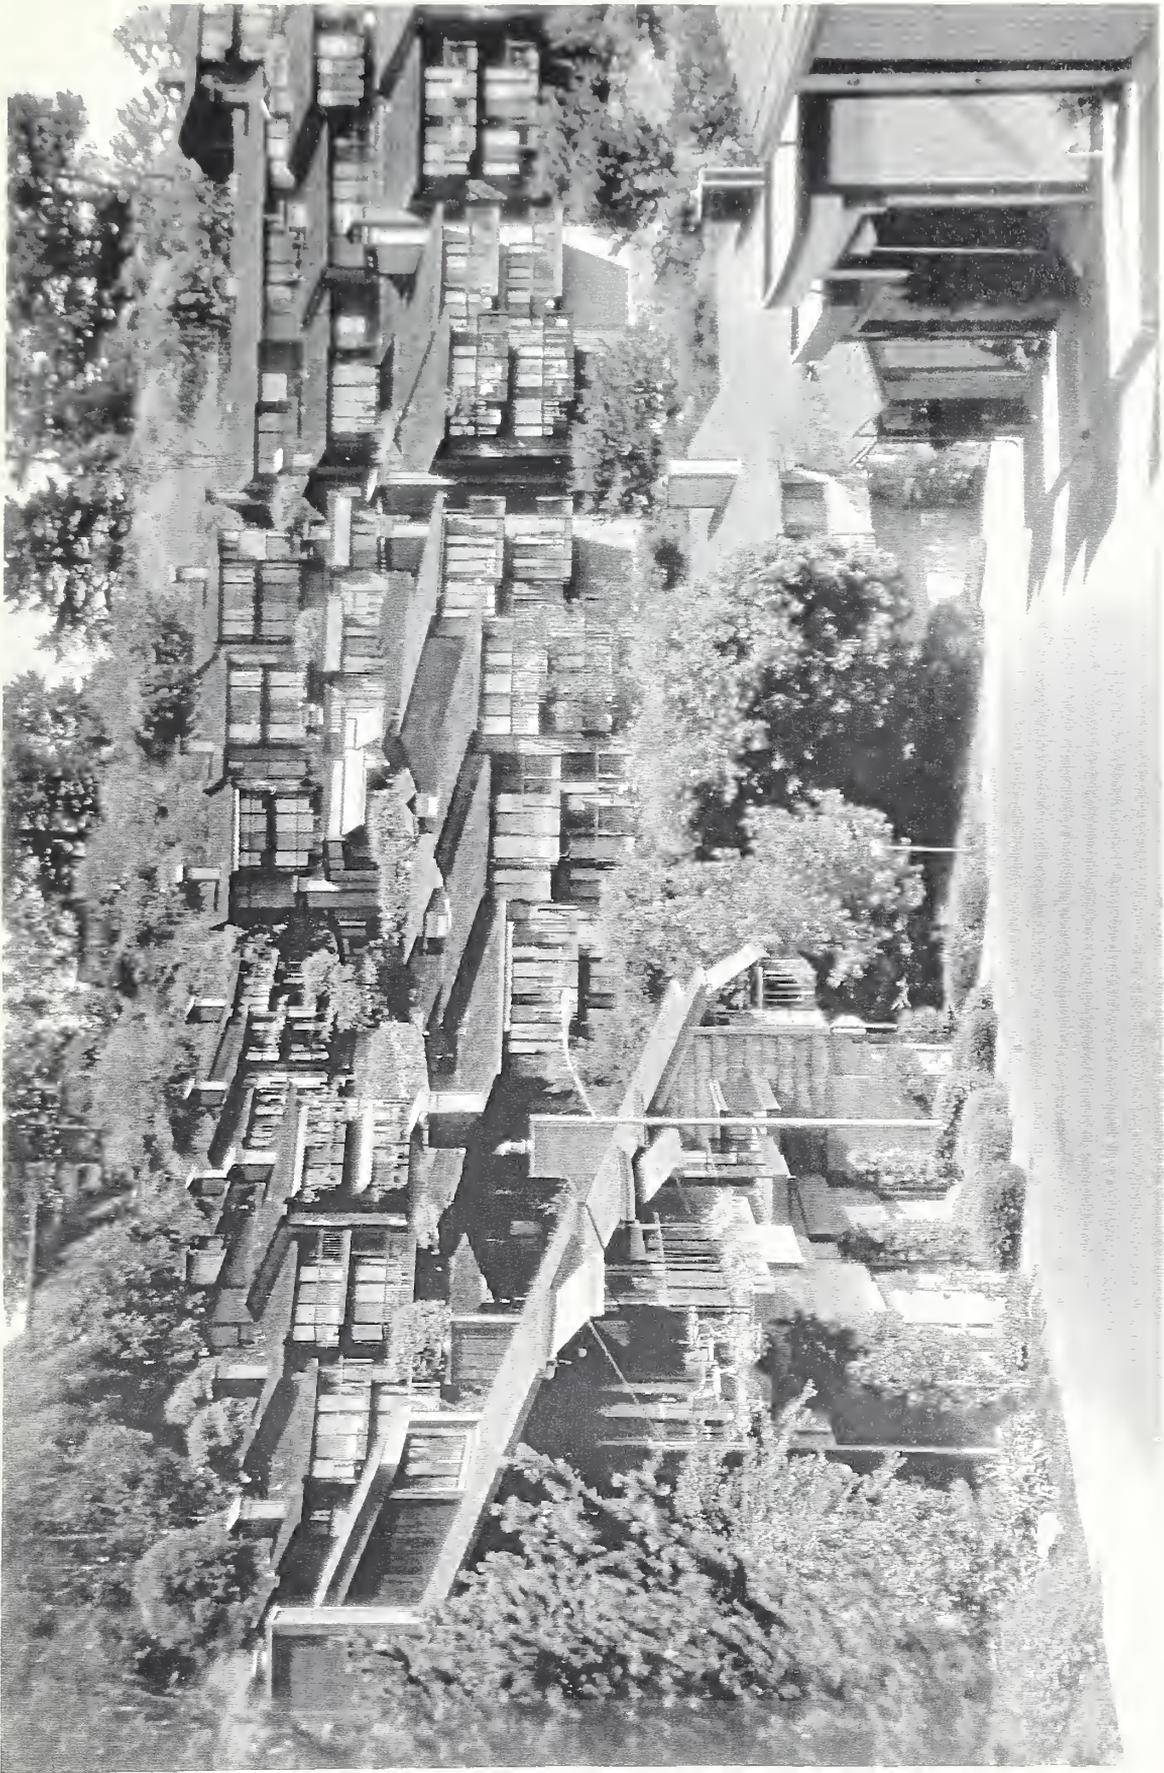
The fire began in an area that was on the edge of the developed land on the west side of Grizzly Peak Boulevard. Housing in that area is relatively sparse, compared to the high density attached housing found in the Hiller Highlands subdivision. Figure 13 shows a section of the Hiller Highlands subdivision before the fire. Dwellings are closely spaced or attached to one another. Often vegetation is found throughout the open areas and in some cases in contact with the buildings. The fire approached the development from the other side of the hill shown in the picture (figure 13). The fire moved through the community in less than one hour, reducing the development to the rubble and ashes seen in figures 14 and 15. The burning of this housing development was not

Figure 13. Section of the Hiller Highlands subdivision prior to the Oakland hills fire. (Photograph by Richard Warwick published in the Oakland Tribune, October 27, 1991).
